Holistic Energy Renovation of Pre- and Postwar Apartment Blocks in Denmark

Eriksen, Marlene Stenberg Hagen; Rode, Carsten; Bjarløv, Søren Peter

Publication date:
2013

Eriksen, M. S. H., Rode, C., & Bjarløv, S. P. (2013). *Holistic Energy Renovation of Pre- and Postwar Apartment Blocks in Denmark*. Paper presented at Central Europe towards Sustainable Building 2013, Prague, Czech Republic.

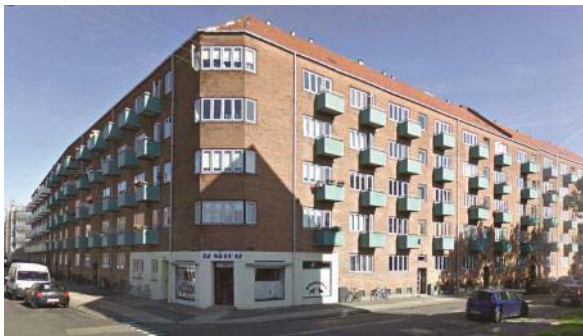
Fig. 3 The case building Kretahus

The technical investigations show that the building is in an acceptable state; albeit that some building parts need maintenance.

The facades are massive and un-insulated. The ceiling below the attic and the floor above the basement are un-insulated. The windows are relatively new, and the doors are old and not tight. External stairs are in a bad condition. The balconies are not large enough to contain furniture. The central heating system is the original one-string system and in several apartments the radiators are placed centrally, away from the facade. Measurements of the thermal indoor climate show temperatures around 20°C. The building is naturally ventilated, with exhaust from kitchen and bathroom. Measurements of the relative humidity show large fluctuations, especially when the shower is in use and, most likely, also when the inhabitants are cooking.
